MONROE CITY DAM
RALLS COUNTY, MISSOURI
MO. 10542

PHASE I INSPECTION REPORT NATIONAL DAM SAFETY PROGRAM.

JANUARY 1979

Name of Dam: Monroe City Dam, Missouri Inv. No. 10542
State Located: Missouri
County Located: Ralls
Stream: Ely Creek
Date of Inspection: September 30, 1978

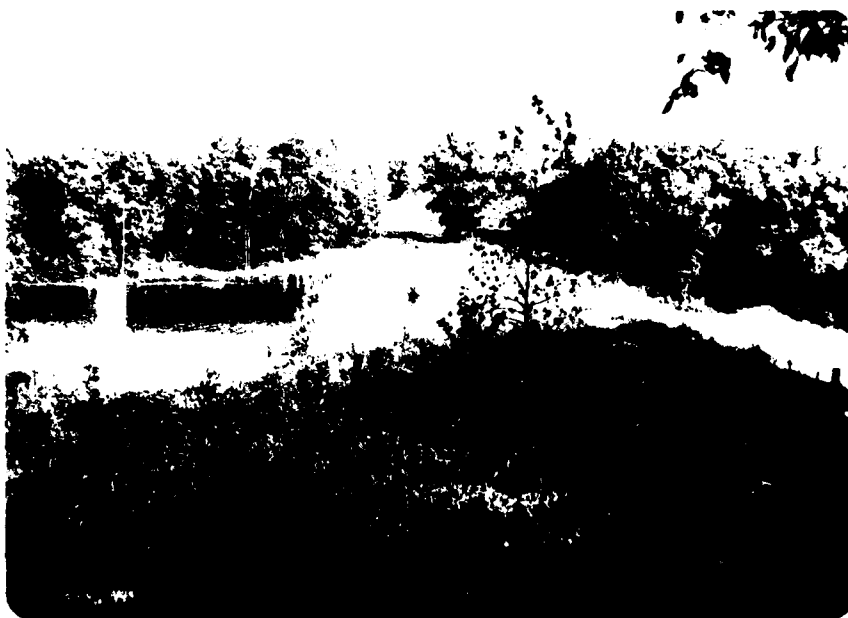
Photo 1 - View along crest and upstream slope of dam taken at right abutment.

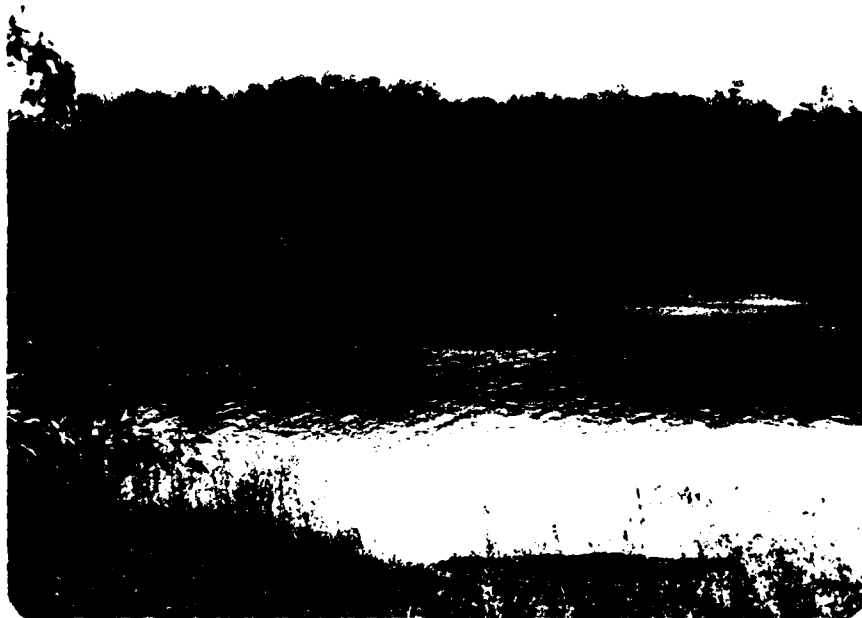
Photo 3 - Picture of upstream slope of embankment taken at left abutment.

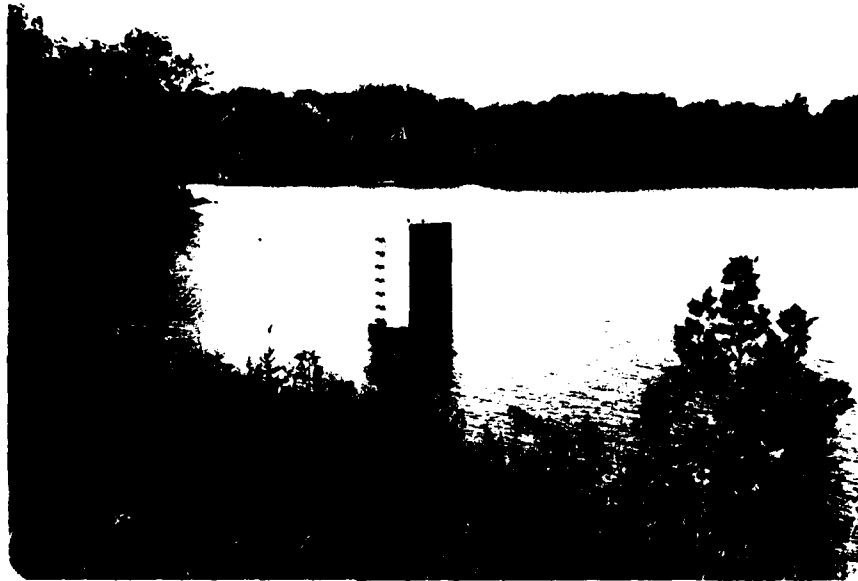
The observed portions of concrete in the intake tower and headwall were seen to be in good, sound condition. The closure flange on the outlet pipe is firmly bolted in place, but has a light coating of rust. The pump station was locked and its interior could not be inspected.

Photo 7 - Picture of intake structure for water supply piping.
